Protection of Terminal Distribution Transformers: A Case Study of Kenya Power

Abstract— The paper presents and analyses the main causes of high failure rate of Terminal Distribution Transformers (TDTs) in Kenya. These transformers are the most susceptible to faults emanating from lightning strikes and associated overvoltage. Over a period of time and more recently, the failure rate of the TDTs have been on an upward trend despite the standard earthing and protection systems being provided. Failed TDTs are quickly replaced without due diligence for innovative ideas to prevent future failures leading to huge revenue loss for Kenya power and electricity consumers. This research therefore provides an innovative solution for TDTs by extending the Medium Voltage (MV) power line one span away from the TDT where installation of Terminal Surge Diverters Earth (TSDE) and Terminal Medium Voltage Earth (TMVE) are done. The results show that with the adoption of this innovative arrangement, the failure rate of TDTs have reduced significantly.

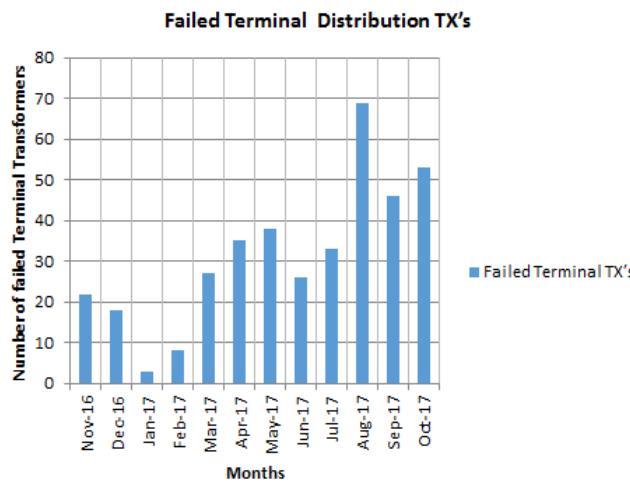
Voltage surges that cause transformer failure may be due to lightning, single phasing, overload or internal defects. The overloading of the distribution transformer normally weakens its internal windings resulting in short-circuit of some winding of the same phase that ultimately causes insulation failure. The degraded insulation of the windings results in overheating of the transformer and acceleration of failure rate under voltage surges. From Table 1, it can therefore be concluded that 14% of all distribution transformers in one year failed due to lightning strikes. In this paper, the very high failure rate of TDTs due to lightning strikes is addressed through the extension of MV power line one span away where earthing is done and tested. Fig. 2, shows the TDTs failure over a period of one year while Fig. 3, shows the failure trend of distribution transformers in the last two years as a result of lightning strikes. The lightning strike generates a wave that travels at almost the speed of light. When this wave runs into a weaken impedance transformer, the wave continues in the same direction. The wave also reflects back in the opposite direction from which it comes at double the magnitude and unless it is discharged to ground, it will severely damage TDT because it is the first target due nature of their terminal location in the power system network.

Fig. 2. Trend of failed terminal transformers in Kenya

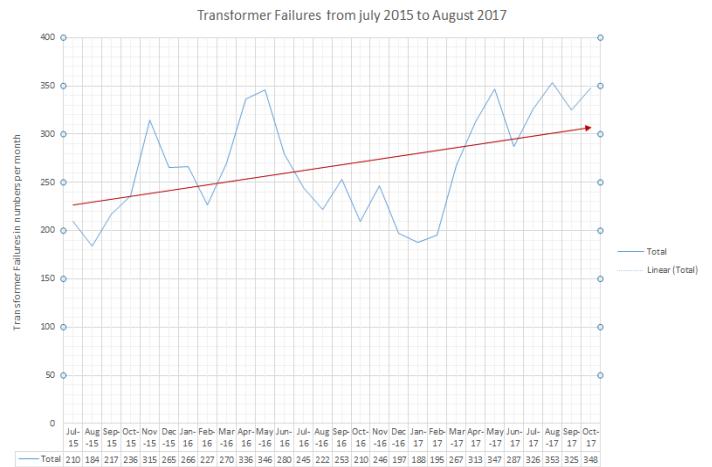
Fig. 3. Trend of transformer failure in Kenya per month

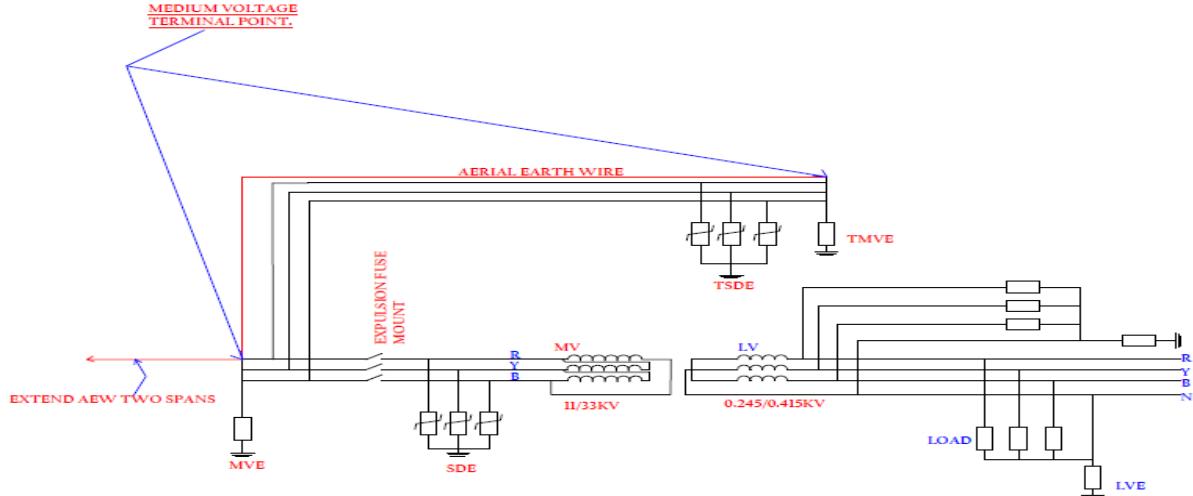
Fig. 4. Innovative protective arrangement for Terminal distribution transformer

Despite having medium voltage earth, surge diverter earth and LV one span way earth, the failure rate for TDTs is still high. In this work, the extension of the medium voltage power line by one span away from the TDT so that the installation of the medium voltage earth and surge diverter earth are separated is proposed. The earthing is done to ensure that TMVE and TSDE are less than that of the TDT earths thereby creating a low resistance path for surges to

flow in the event of lightning surges. The low resistance path for the surges to flow will be the TMVE and TSDE to the ground thus safeguarding the TDTs. The above proposal is also enhanced by running an aerial earth wire above the MV power line for a distance of 100m from the power source and 50m to the terminal point thereby ensuring the TDT is fully protected against voltage surges. The TMVE is connected to the aerial earth wire then well grounded. Fig. 4, Shows the proposed and implemented electrical circuit arrangement for enhanced protection of TDTs where the symbols SDE stands for Surge diverter earth, MVE stands for Medium voltage earth and LVE stands for Low voltage earth respectively.
